Electrocautery-induced Inappropriate Implantable Cardiac Defibrillator Shock

Dante Antonelli MD¹, Vladimir Poletaev MD^{1,2}, Vidal Essebag MD², and Alexander Feldman MD¹

IMAJ 2023; 25: 245–246

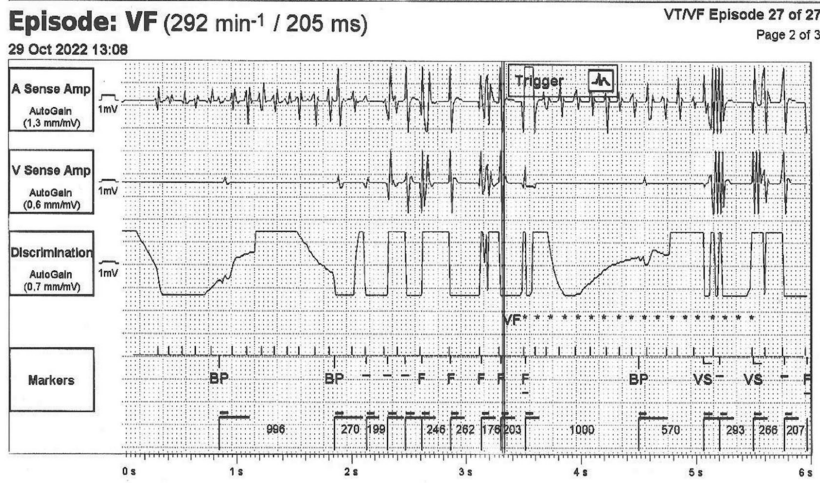
A subsequent CRT-D interrogation confirmed its normal functioning and inappropriate intraoperative 30 joule shock due to EMI [Figure 1].

Figure 1. Stored electrogram from the CRTD
 First line: atrial electrogram channel
 Second line: ventricular electrogram channel
 Third line: far field electrogram channel; forth line: marker annotations

[A] Artefacts are seen in all channels and are erroneously interpreted as ventricular fibrillation (VF)

On the day of surgery, the patient was placed in the supine position and the EDP on his left flank. The surgery was conducted with the use of monopolar electrocautery and the CRT-D defibrillated. The surgical procedure was paused and a magnet was placed on the CRT-D. The procedure was completed with no complications.

By using monopolar electrocautery, not only the location of surgery but also EDP placement may have an important role in avoiding inappropriate shock due to EMI. Given the limited evidence regarding the efficacy of optimal EDP positioning in various types of surgery, it remains prudent to place a magnet over the ICD to suspend the antitachycardia therapy while monopolar electrocautery is used.

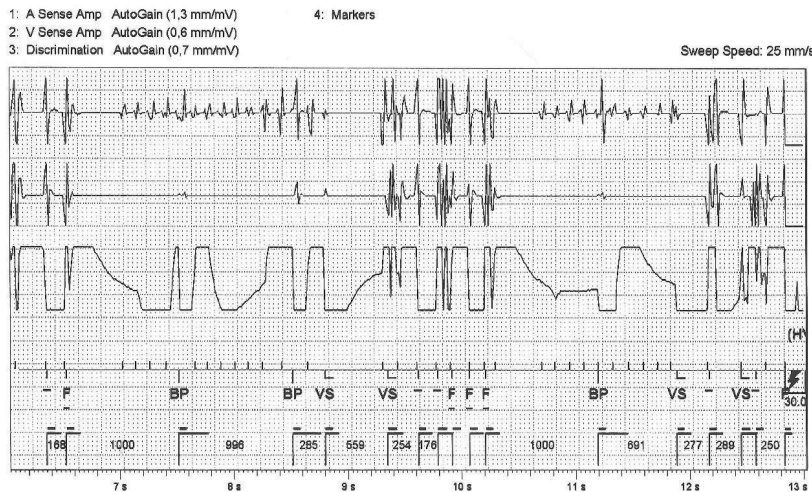
During pelvic surgery using monopolar electrocautery the EDP was proposed to be positioned on the thigh or buttock contralateral to the side of surgery [2]. Our patient underwent surgery under the umbilicus and the EDP was placed on the left flank. The EDP returned current might have interfered with the CRT-D and caused EMI.

[B] CRTD discharges of 30 joule shock ()
